Home Inspection Report

50's Ranch
Nashville, TN 37215

Prepared By:
Carlson Inspection LLC dba
Carlson Home Inspection Services

Bill Carlson; P.E. (Louisiana Inactive)
TN State Home Inspector License # 63

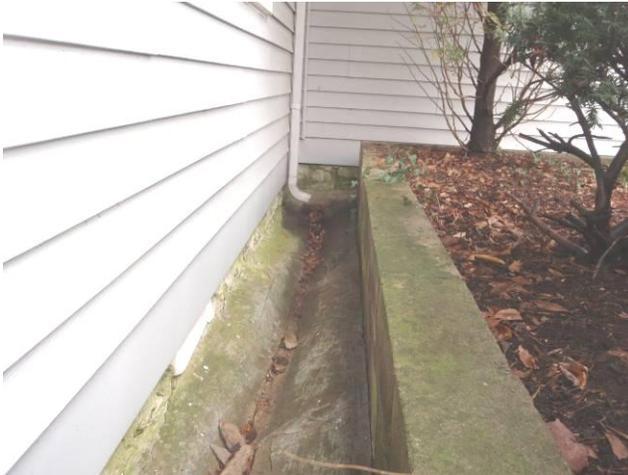
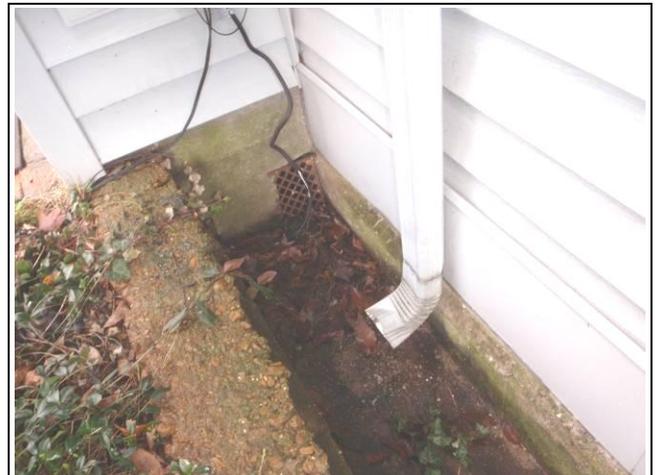
Photo 1 Drainage channel along front of house.

Photo 2 Drainage channel along front of house.

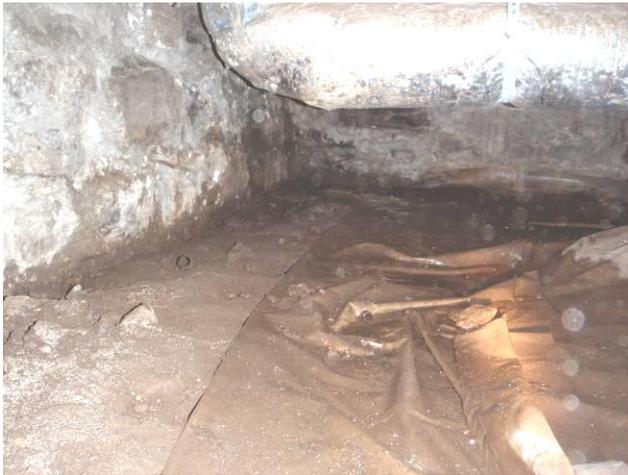
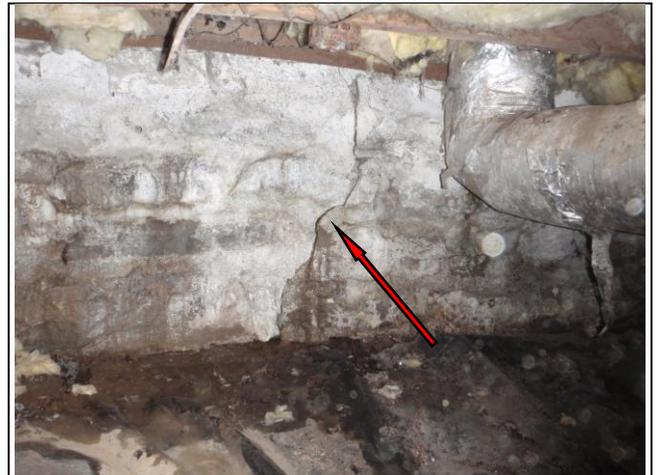
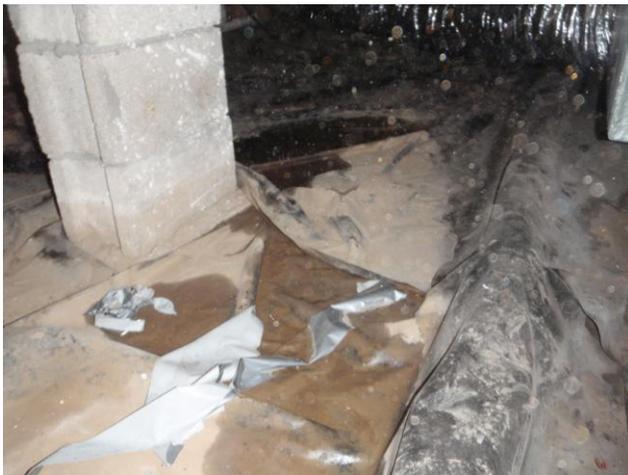
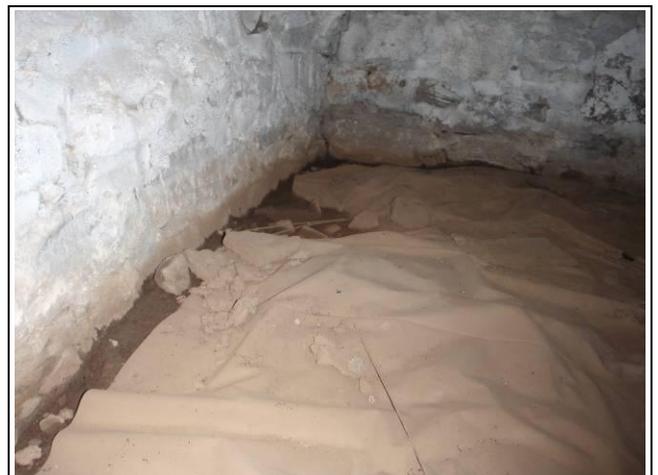
Photo 3 Crawl space moisture.

Photo 4 Crawl space moisture @ crack.

Photo 5 Crawl space moisture.

Photo 6 Crawl space moisture; water line.

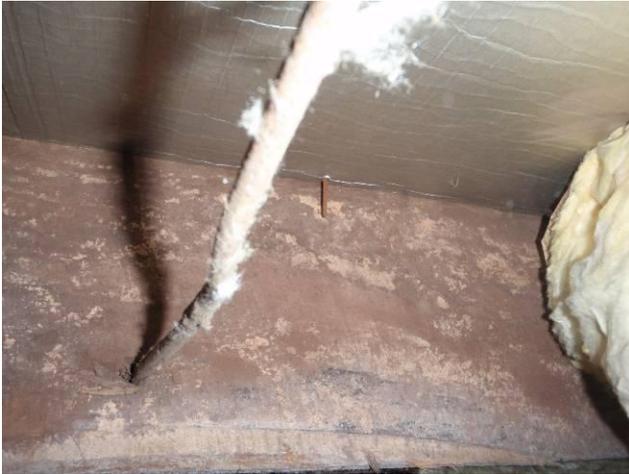
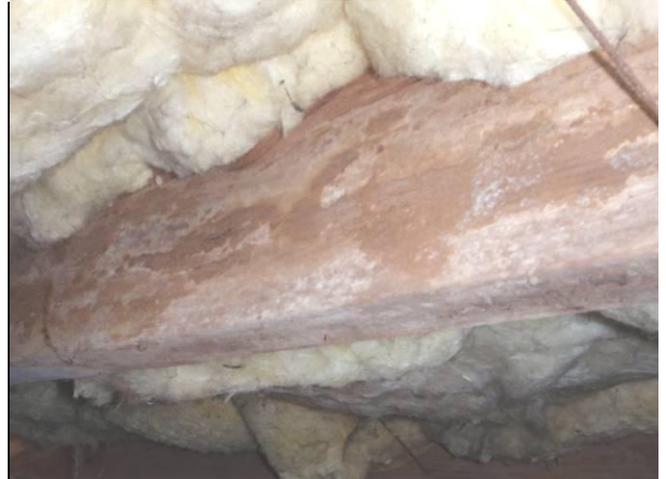
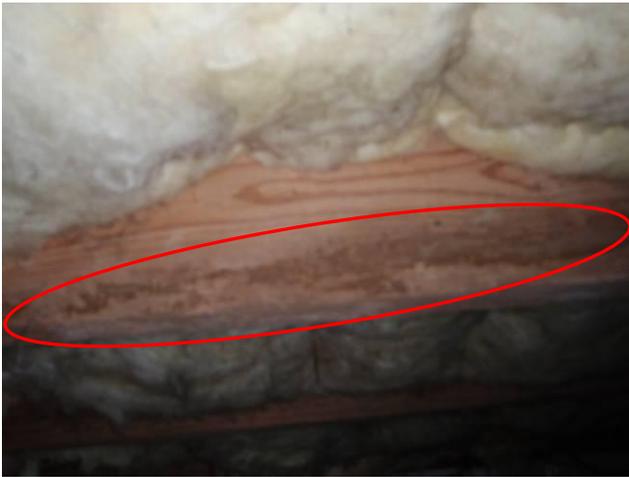
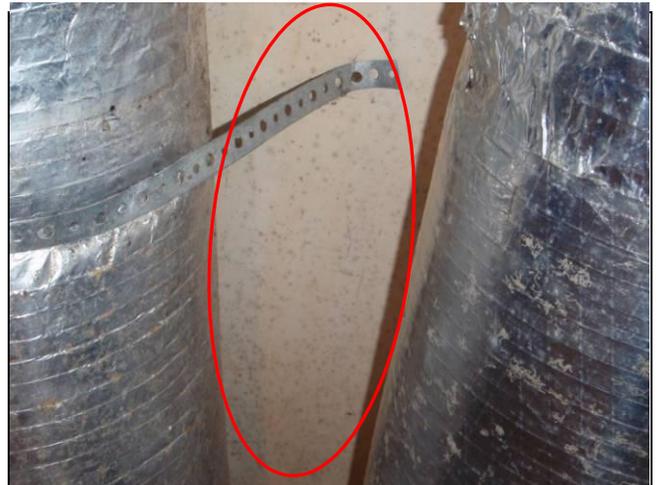
Photo 7 Evidence of mold/mildew.

Photo 8 Evidence of mold/mildew.

Photo 9 Evidence of mold/mildew.

Photo 12 Evidence of mold/mildew.

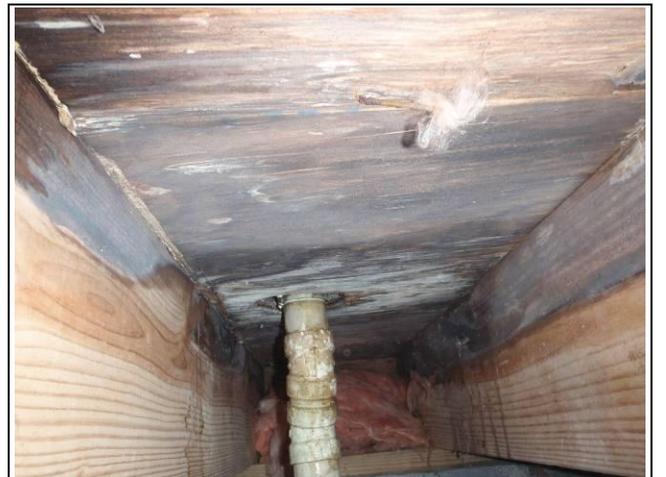
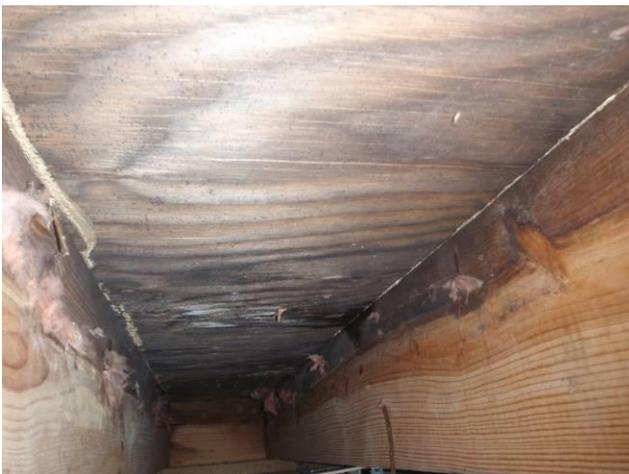
7. **Repair/Query:** A significant prior leak was experienced in the master bathroom addition at some time visible from the crawl space (See photos 10 and 11 page 9). The moisture source was the shower. The sub-flooring was saturated for sometime indicated by the consistent presence of evidence of mold/mildew. The sub-flooring appears to be structurally stable but may require replacement to perform a proper mold/mildew remediation as the top side and cross section of the sub-flooring is not accessible for treatment. It is noted the shower drain and an area at the corner or door of the shower were wet and actively leaking at the time of inspection (See photo 17 and 18 page 10).

Photo 10 Evidence of mold/mildew.

Photo 11 Evidence of mold/mildew.

- **Repair/Query:** A significant prior leak was experienced in the master bathroom addition at some time visible from the crawl space (See photos 10 and 11 page 9). The moisture source was the shower. The sub-flooring was saturated for sometime indicated by the consistent presence of evidence of mold/mildew. The sub-flooring appears to be structurally

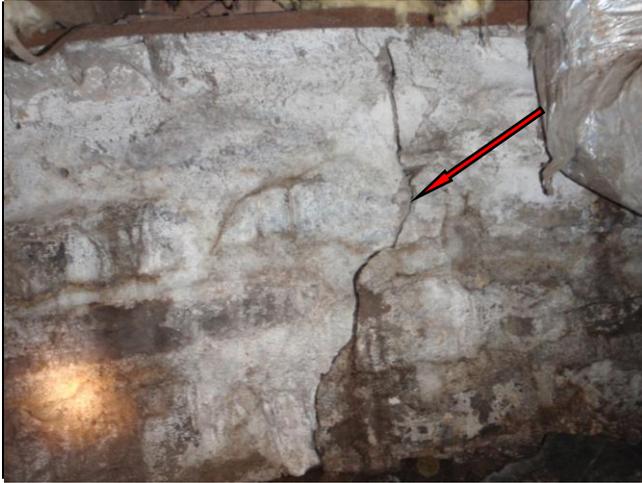
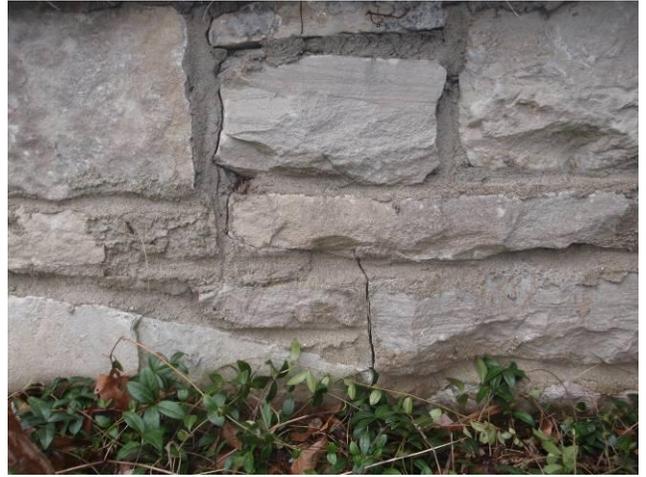
5. **Repair/Query:** There is a notable foundation crack at the midspan of the front at the east section of the home (See photo 13 page 10). A measure of bow is present as well. The crack is located at the apex of moisture entry beneath this wall from the exterior. The crack is likely the result of hydrostatic forces from moisture entry. Minor cracks were also observed at the east side foundation wall as well but are less significant (See photo 14 page 10). Moisture entry should be eliminated and structural repair may be required.

Photo 13 Foundation crack.

Photo 14 Foundation crack.

- **Repair/Query:** There is a notable foundation crack at the midspan of the front at the east section of the home (See photo 13 page 10). A measure of bow is present as well. The crack is located at the apex of moisture entry beneath this wall from the exterior. The crack is likely the result of hydrostatic forces from moisture entry. Minor cracks were also observed at the east side foundation wall as well but are less significant (See photo 14 page 10). Moisture entry should be eliminated and structural repair may be required.

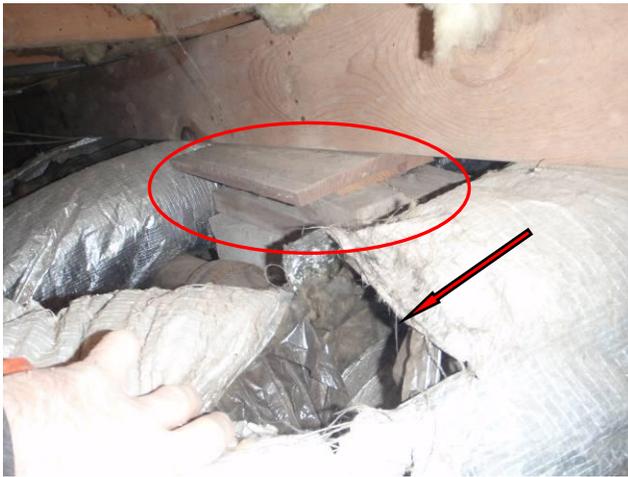
Photo 15 Shims moved by hand; open duct.

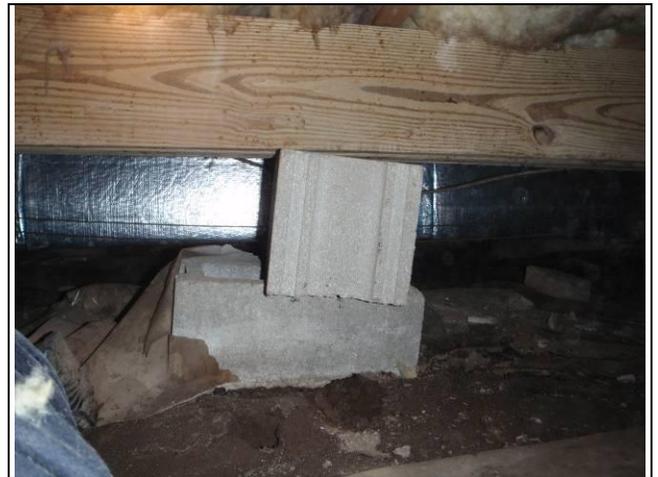
6. **Repair:** Supplemental support girder assemblies have been installed in the crawl space at the fireplace front entry room oriented in the east/west direction and below the dining room oriented in the north/south direction. The girder supports are of dry stacked concrete block with wood shims without footings present. Moisture presence in these areas has caused instability in the girder supports. The middle support of the dining room girder can be moved by hand (See photo 15 page 10) and is inactive and other supports at this girder are leaning. The entry room girder supports are all unstable and the girder can be moved by hand and is inactive (See photo 16 page 10). Moisture entry should be eliminated and structural repair will be required.

Photo 16 Girder can be moved by hand.

- **Repair:** Supplemental support girder assemblies have been installed in the crawl space at the fireplace front entry room oriented in the east/west direction and below the dining room oriented in the north/south direction. The girder supports are of dry stacked concrete block with wood shims without footings present. Moisture presence in these areas has caused instability in the girder supports. The middle support of the dining room girder can be moved by hand (See photo 15 page 10) and is inactive and other supports at this girder are leaning. The entry room girder supports are all unstable and the girder can be moved by hand and is inactive (See photo 16 page 10). Moisture entry should be eliminated and structural repair will be required.

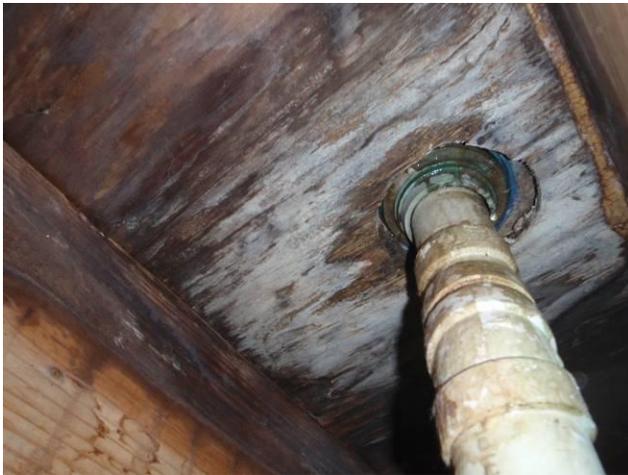
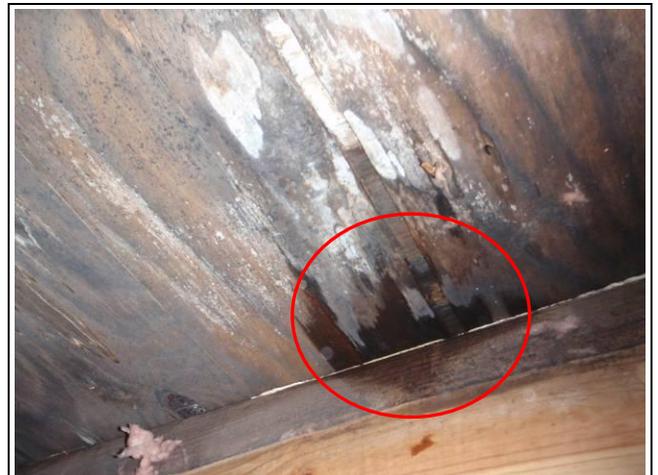
Photo 17 Active drain leak.

Photo 18 Wet area under shower from crawl space.

stable but may require replacement to perform a proper mold/mildew remediation as the top side and cross section of the sub-flooring is not accessible for treatment. It is noted the shower drain and an area at the corner or door of the shower were wet and actively leaking at the time of inspection (See photo 17 and 18 page 10).

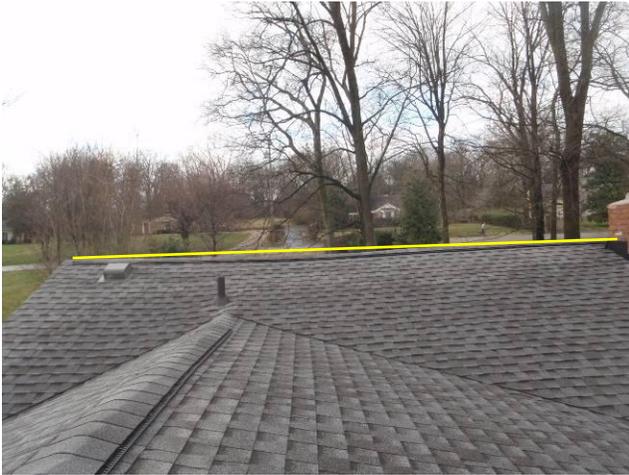
8. **Repair/Query:** The ridge of the roof exhibits minor sagging at the east section likely from the load of the front and rear gables (See photo 19 page 11). Structural repair may be required.

Photo 19 Ridge sag.

- **Repair/Query:** The ridge of the roof exhibits minor sagging at the east section likely from the load of the front and rear gables (See photo 19 page 11). Structural repair may be required.

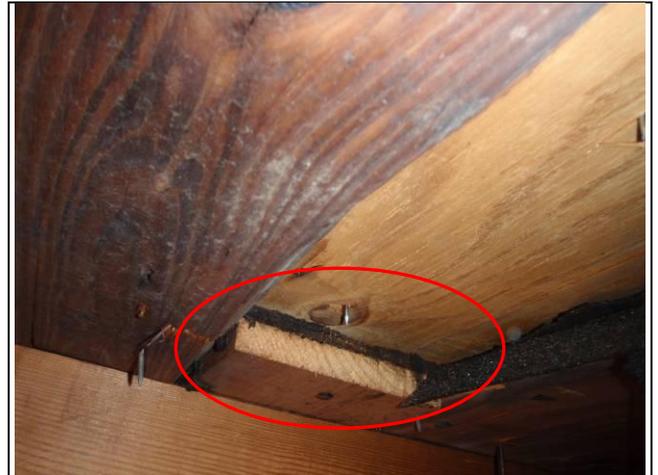
Photo 20 Old roof surface between new and old decking.

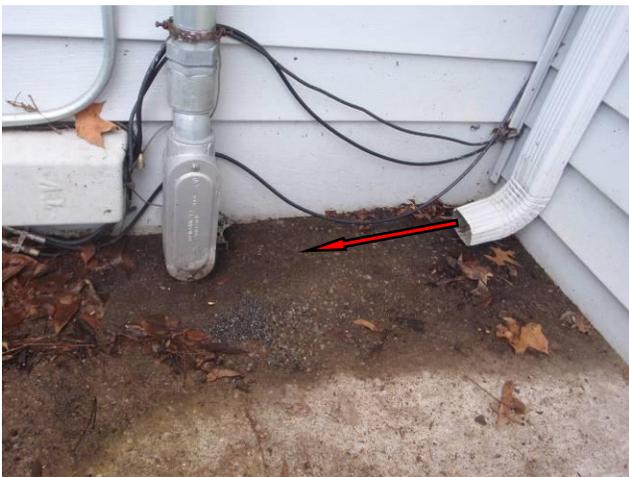
Photo 21 Downspout discharging at conduit.

- **Repair:** The downspouts should discharge water at least 10 feet from the house on soil graded away from the foundation. Storm water should be encouraged to flow away from the building at the point of discharge. This is a common contributor to water in crawl spaces and basements. The downspout at the rear west end should be extended to discharge away from the main electrical service conduit to reduce the risk of moisture exposure at the conduit (See photo 21 page 11).

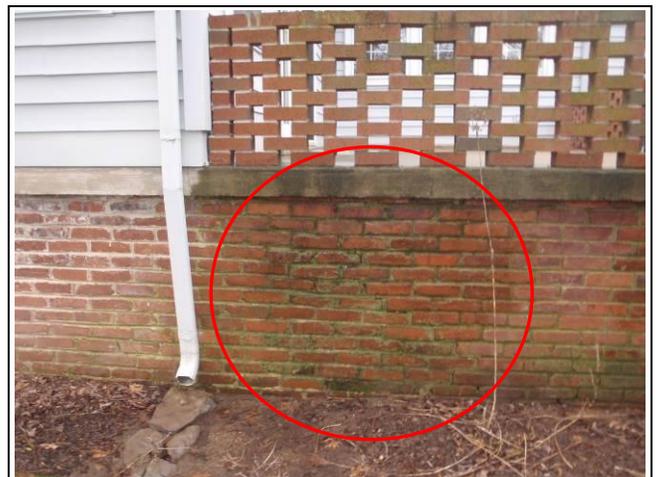
17. **Repair:** The rear east porch is pitched to drain. Water runs down the north side of the brick porch structure (See photo 22 page 11). The brick veneer exhibits deterioration and cracking in this area. Moisture drainage at the foundation in general is not recommended. A gutter system should be installed to catch the porch water and discharge at least 10' from the foundation. The current drains at the rear west porch should be extended to discharge away from the foundation as well.

Photo 22 Porch drainage.

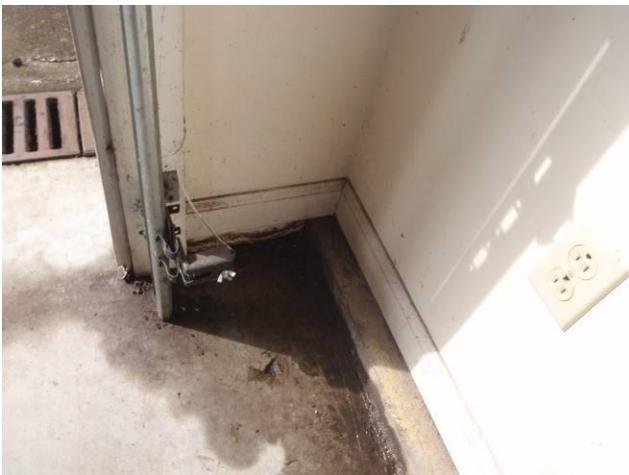
21. **Repair:** Water was observed in the garage at the time of inspection and appears to enter through the bottom of the wall between the overhead door and garage corner indicated by damaged interior trim (See photo 23 page 11). This

should be corrected and exterior drainage should be adjusted. Damaged interior wall trim as well as any hidden wall damage should be replaced.

Photo 23 Water entry to garage.

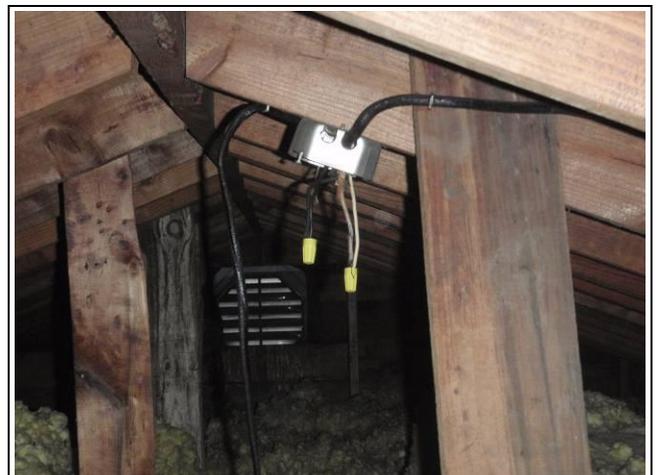
25. **Repair:** All junction boxes at the attic should be fitted with cover plates, in order to protect the wire connections (See photo 24 page 11).
26. **Repair:** Improper electrical connections should be repaired at the crawl space (See photo 25 page 12). All electrical connections should be made in properly sized, secured, and covered junction boxes.

Photo 24 Missing cover.

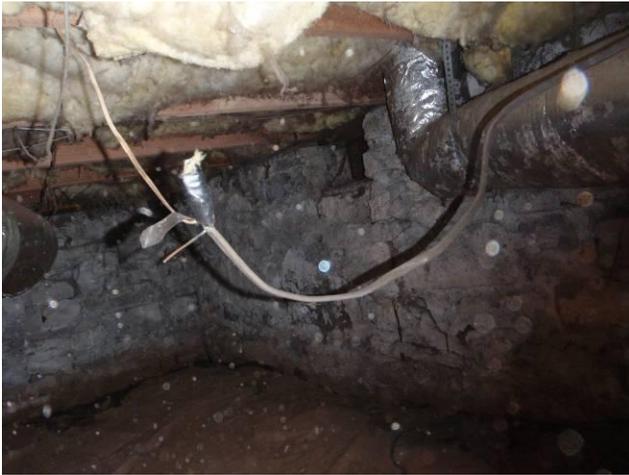
Photo 25 Improper wiring and connections.

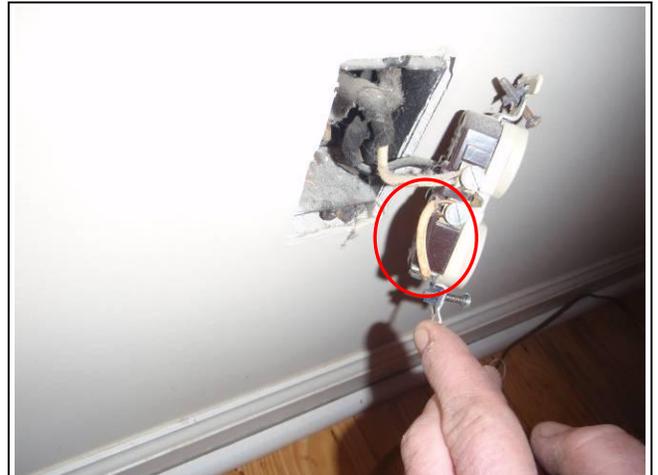
Photo 26 Jumper wire between N and Equ ground terminals.

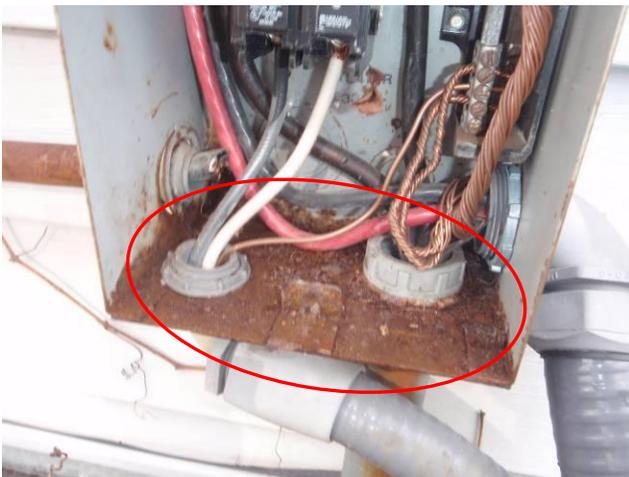
39. **Repair:** The heat pump system electrical disconnect panel is significantly corroded at the exterior and interior and the interior was wet @ the time of inspection (See photo 27 page 12). The panel should be replaced.

Photo 27 Rusty wet panel interior.

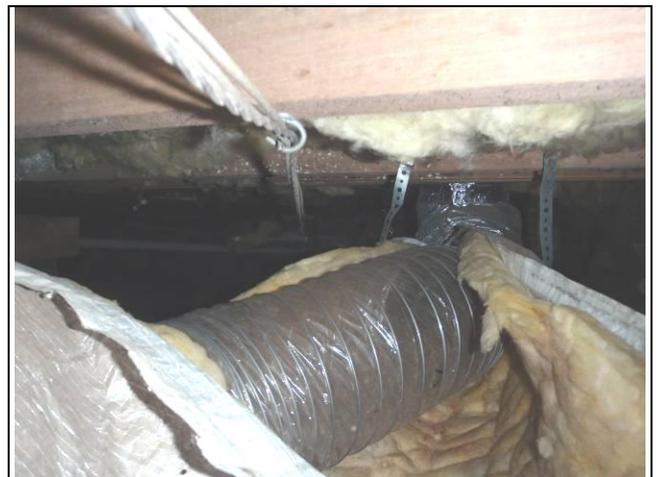
41. **Repair:** The dirty HVAC air filter should be replaced.
42. **Repair:** The ductwork is in a damaged condition at the west end with insulation pulled away (See photo 28 page 12), a large opening present (See photo 15 page 10), and sections running along the ground where not necessary due to clearances (See photo 29 page 12). Duct opening may be present near the unit as well. Older ductwork is present with unsealed joints and in general will be leaky. A licensed HVAC contractor should be contacted to replace, repair, and re-organize the ductwork as needed to optimize performance.

Photo 28 Damaged duct insulation.

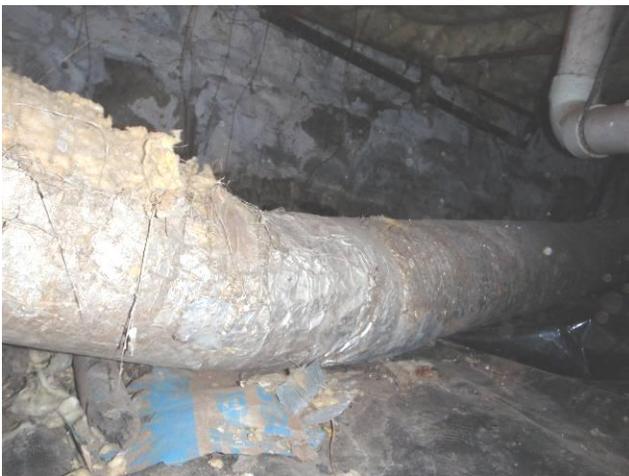
Photo 29 Older duct lying on ground.

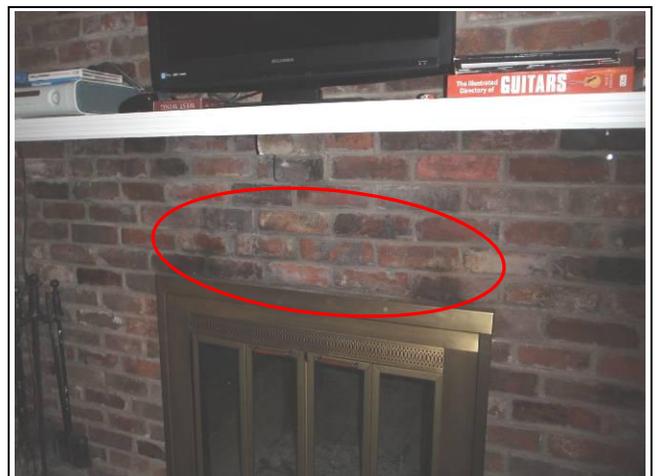
60. **Replace:** The west den has a noticeable smoke odor. Evidence of back drafting was observed at the fireplace front (See photo 30 page 12). Minor mortar damage and creosote build up were observed in the fire box and flue respectively. A licensed chimney technician should be contacted to evaluate and perform repairs. The fire place should not be used until these issues are addressed.

Photo 30 Evidence of back drafting.
